National Register of Historic Places Registration Form

historic name Antelope School

street & number 45500 McGreer Street not for publication

state Oregon code OR county Wasco code 065 zip code 97001

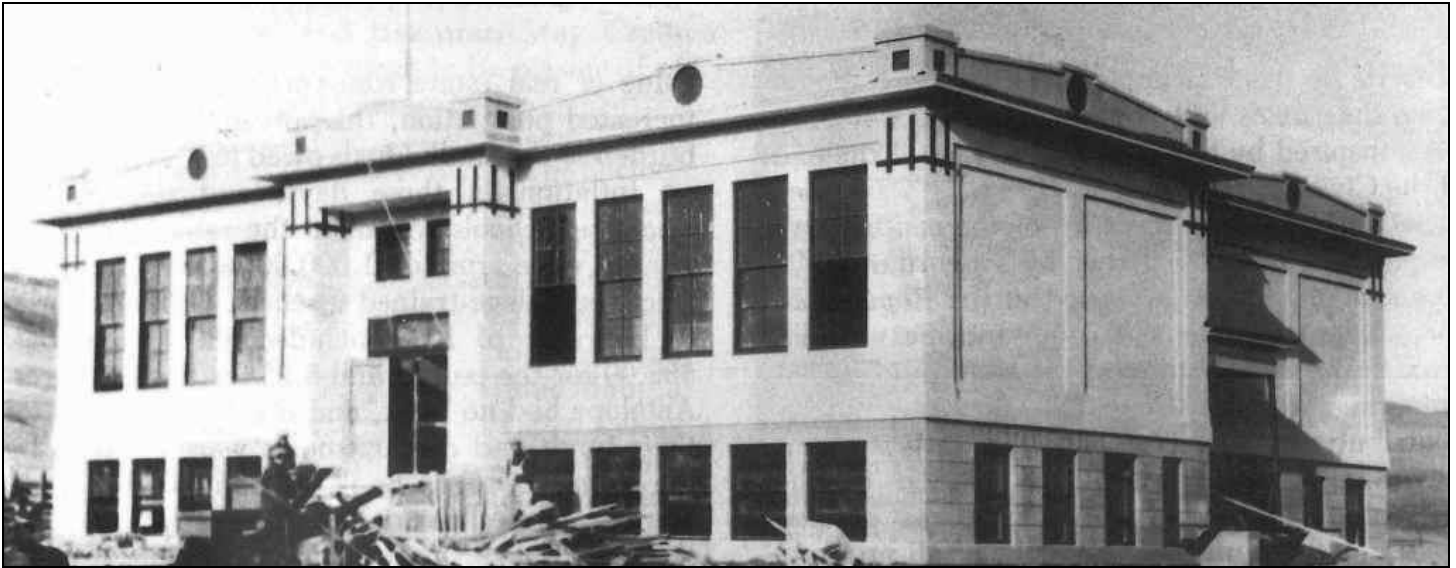
Figure 6: Antelope School, nearing completion, likely taken in fall, 1924⁵⁰

As originally constructed (Figure 6), the Antelope School included a simple, flat cornice and Craftsman-inspired wood details supporting the cornice at corners and pilasters. It is unknown when these were removed, though the scars from these features can still be seen. Plywood has been applied over the lower panels of the front doors, though it is believed that the original panels remain behind this. On the side elevations, both side entries (at ground level) were originally constructed with a large opening approximately the size (and likely matching) the doors and transom/sidelights of the front entry, and both

were (apparently – these are difficult to see in the few historic photos) covered by a flat entry roof supported by a single fluted column or half (engaged) column in the outside corner of the landing. Both of these entries have been largely enclosed to accommodate a single door, and neither retains the roof or column. On the south side entry, a removable steel ADA ramp has been attached to the concrete landing.

Windows throughout the building were wood sash, multi-light windows, generally 4-light in the basement and over the main entrance (either fixed or hopper or awning sash – this is unclear from the photos), and four-over-four wood sash in the first floor front elevation, and likely rear elevation (gymnasium). All of the windows in the building, with the exception of those at the entrance (transom and sidelights, doors) appear to have been replaced at least once during the life of the building. On the first floor, the building currently has inappropriate aluminum windows in the front elevation, first floor (classrooms), windows over the side entrances have been enclosed with concrete block, and on the rear, original large gymnasium windows (of which there are no known photos, but likely originally matching those on the front elevation) have been either entirely closed with concrete block (6 out of 10), partially enclosed to include paired casement windows high within the opening (3 of 10), or converted to an emergency door (1 of 10, with casement windows above) with a concrete emergency stair to the ground surface. Around the basement level, 14 out of 36 windows have been enclosed with concrete block, and an additional nine have been replaced with inappropriate aluminum windows. All of the enclosed and replaced windows are on side and rear elevations. Wood windows remain across the front elevation at the basement level, but these appear to have been replaced as well.
